PROPERTY CONDITION REPORT

Dec 08, 2025

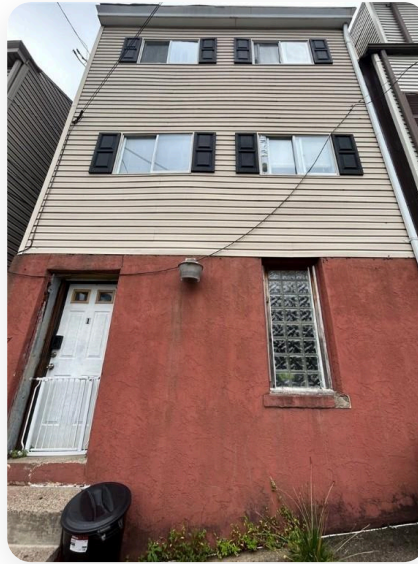
— Need Attention

The stucco exterior appears to be missing a visible weep screed (It's not completely clear if a weep screed is present). According to IRC R703.7.2.1, plaster wall systems such as stucco must terminate at least 4 inches above earth and 2 inches above paved surfaces, instead the stucco has been ran straight into the ground. The lower stucco finish shows vertical staining and possible biological growth near the base, suggesting moisture absorption. Stucco damage is also visible around windows, and the door frame appears deteriorated. The upper levels, clad in vinyl siding, appear generally intact.

Without a weep screed and proper ground clearance, stucco can absorb moisture through capillary action, potentially leading to concealed wood rot and structural damage. This condition indicates a common but improper installation practice. Correction can be costly and requires specialized skill, as it typically involves cutting the stucco higher and installing a proper weep screed. The staining near the base may indicate ongoing moisture intrusion, and the damaged door frame could continue to deteriorate if not addressed.

Hire a qualified stucco contractor to verify the presence or absence of a weep screed and, if missing or improperly installed, to modify the system to meet the clearance requirements in IRC R703.7.2.1. Have the contractor also assess and repair the damaged door frame and any localized stucco or moisture-related issues at the entryway. Hire a qualified carpenter to address any doorway issues such as wood rot, etc.

Total Estimate: \$3,000-\$3,500

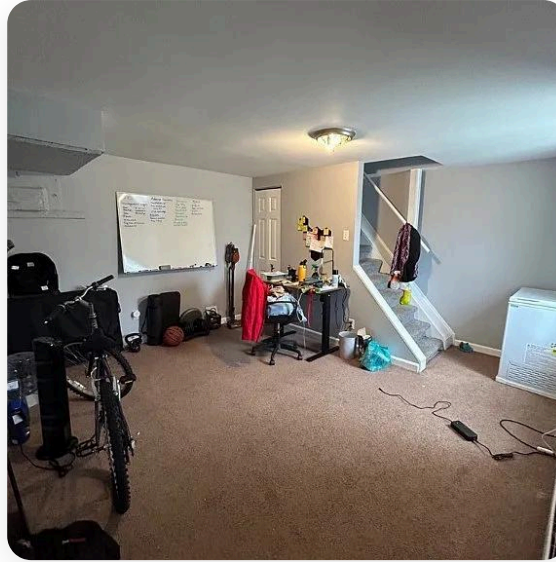
— Need Attention

The existing handrail for the staircase is not continuous. Per IRC R311.7.8.4 (2021), at least one handrail must extend the full length of the flight, beginning directly above the top riser and ending directly above the lowest riser. Additionally, guards are missing along the open side of the stairs, which is required by IRC R312.1.1 (2021) for elevated walking surfaces that are open (subject to falling). The photo also suggests that electrical wiring or extension cords may be too close to the baseboard heater, posing a potential hazard.

Missing or incomplete handrails and guardrails present a serious fall hazard, particularly for children or older adults. Improperly routed electrical cords near a baseboard heater can overheat, melt, or short out, increasing the risk of electrical fire or damage to connected devices.

Hire a qualified carpenter to install a continuous handrail along the full stair flight in accordance with IRC R311.7.8.4. Also, install guards along the open side of the stairs where an elevated walking surface exists, following IRC R312.1.1. Relocate or remove any electrical cords positioned near the baseboard heater to eliminate potential overheating or fire risk.

Install guardrails and handrails: \$900-\$1500

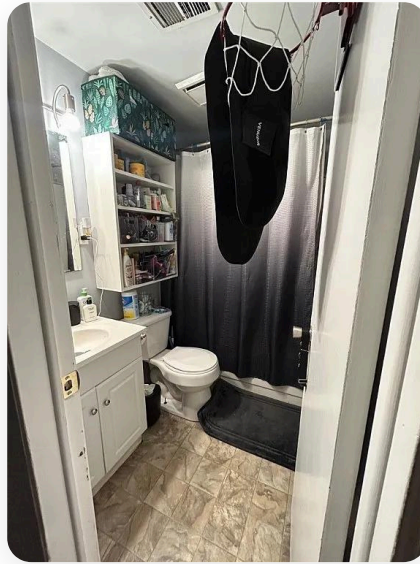
✓ **Fine**

The bathroom outlet appears to have every receptacle in use, suggesting there may be an insufficient number of outlets for the space. It is also unclear whether this outlet is GFCI-protected, as required in bathrooms.

While the primary concern is convenience, an inadequate number of outlets can lead to overuse of extension cords or power strips, which increases the risk of electrical overload. If GFCI protection is not present, there is a heightened risk of electrical shock in this moisture-prone area.

If additional outlets are needed, hire a licensed electrician to install them safely and in compliance with code. Verify that the existing outlet has GFCI protection; if not, have the electrician replace it with a GFCI outlet or install GFCI protection at the circuit level.

Materials and labor: approximately \$150–\$350 per outlet, depending on accessibility and wiring conditions.

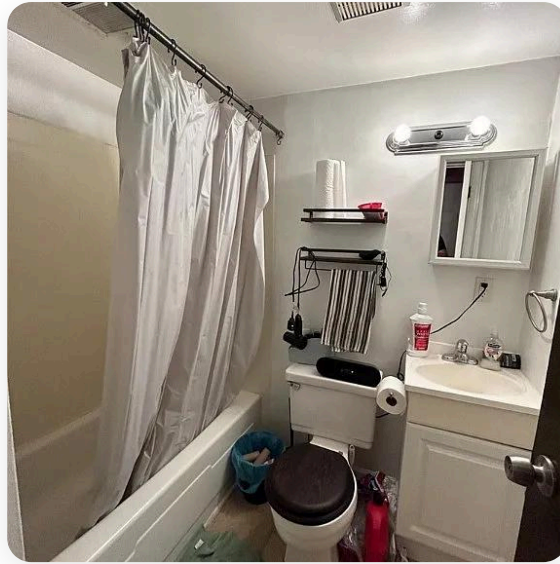
✓ **Fine**

No major defects were detected from this photo

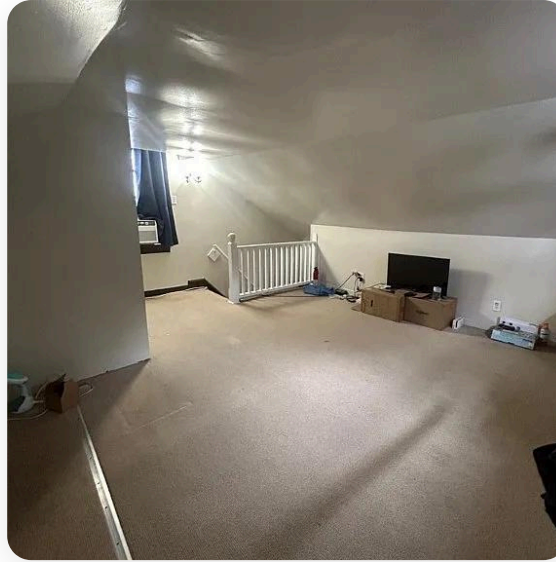
— Need Attention

The finished attic includes sloped ceilings and walls finished with drywall or plaster. A white wooden guardrail protects an opening, but its height appears below code. Per IRC R312.1.2, guards must be at least 36 inches high in residential settings. Additionally, the handrail for the stairs does not extend fully to a point directly above the top riser, as required by IRC R311.7.8.4.

A guardrail that is too low poses a serious fall hazard and does not meet safety standards. Likewise, a handrail that stops short of the top riser increases the risk of slipping or losing balance, as users may not have a secure handhold for the last few steps.

Confirm the guardrail height against local code requirements and replace or modify it to meet the 36-inch minimum. Extend the stair handrail so it terminates directly above the top riser in compliance with IRC R311.7.8.4.

Total estimated cost \$1,000–\$2,000 depending on accessibility and finish quality.

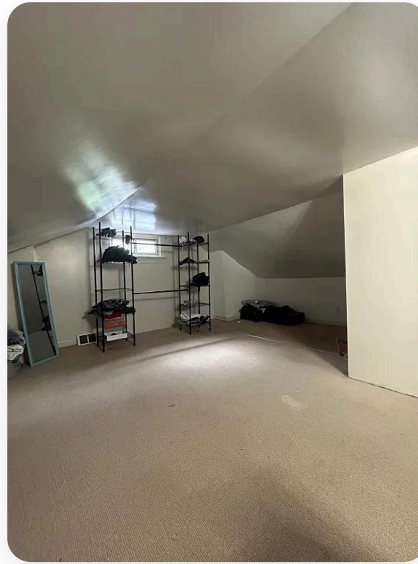
— Need Attention

The window does not qualify as an emergency escape and rescue opening. According to IRC R310.1, every sleeping room and *habitable attic* must have an approved emergency escape and rescue opening. This space appears to be a habitable attic (possibly a conversion), so it must meet those requirements. IRC R310.2.3 specifies that the bottom of the clear opening cannot be more than 44 inches above the floor, and IRC R310.2.1 requires a minimum net clear opening of 5.7 square feet. Based on the photo, it's also unclear if the window meets the minimum width and height dimensions listed in R310.2.2.

A missing or undersized emergency escape and rescue opening poses a serious safety concern, as it could prevent occupants from escaping or rescuers from entering in an emergency. If no compliant opening exists, the attic may have been converted without proper permitting, which can also impact resale value and code compliance.

Verify whether another compliant emergency escape and rescue opening exists in this space. If none is present, hire a qualified carpenter or window contractor to design and install a code-compliant egress window that meets all requirements of IRC Section R310.

Installing an approved egress window or opening: \$1,000–\$4,000, depending on window size, framing modifications, and finish work.

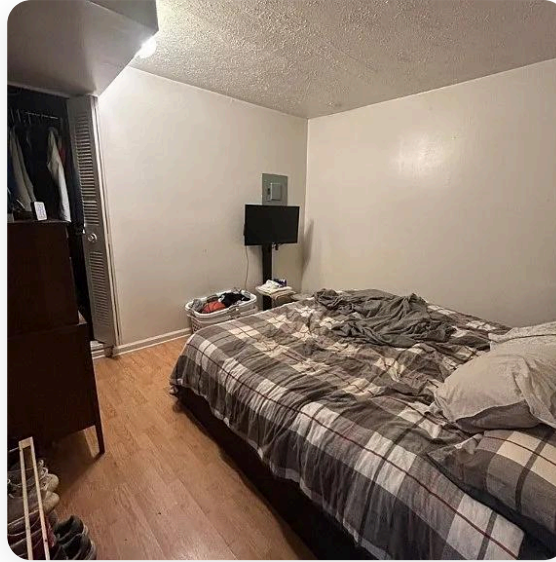
— Need Attention

A gray electrical service panel (breaker box) is surface-mounted on the wall of a habitable bedroom, positioned above a television near the head of the bed. Access to the panel is partially obstructed by furniture and electronic equipment. According to NEC 240.24(D), electrical panels should not be located near easily ignitable materials, and while panels are sometimes found in bedrooms, placement near bedding or combustible materials is discouraged. Additionally, NEC 110.26 requires a minimum of 36 inches of clear working space in front of the panel for safe access.

Improper panel placement and obstruction pose both safety and accessibility risks. Limited clearance can make it difficult to safely shut off power in an emergency or perform maintenance. Placement near combustible materials or electronics increases the risk of heat buildup or ignition in the event of electrical arcing or overheating.

Ensure the panel has at least 36 inches of unobstructed clearance in front and 30 inches of width for safe access. Relocate any furniture or equipment blocking the area. If the panel's location poses safety or code concerns, consult a licensed electrician to evaluate potential relocation or shielding options that meet NEC requirements.

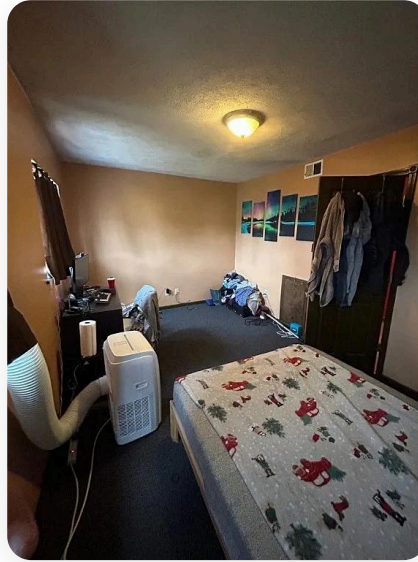
— Need Attention

A window air conditioning unit is present in this room, suggesting the central HVAC system may not be providing adequate cooling.

The need for a window unit typically indicates the central HVAC system is underperforming, improperly balanced, or not reaching this area effectively. This can lead to uneven temperatures, higher energy costs, and potential strain on the overall system.

Have a licensed HVAC technician inspect the system to determine why this room is not being adequately cooled/heated. The technician should check for issues such as blocked ducts, improper zoning, undersized equipment, or insulation deficiencies. Correcting the root cause may eliminate the need for the window unit.

\$200-\$400 depending on issues present

\$5,000-\$10,000 if new HVAC system is necessary

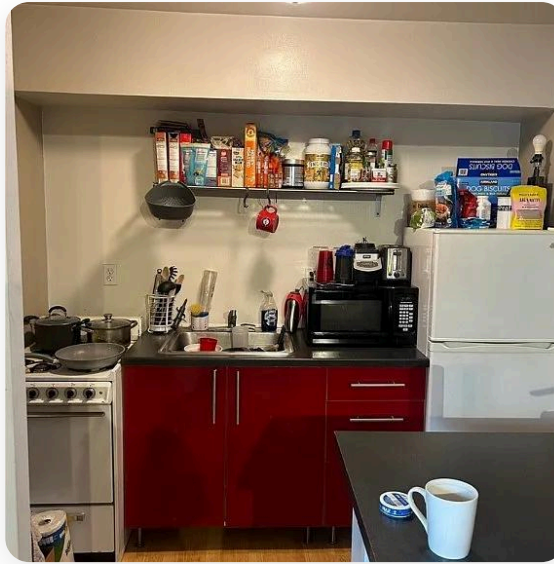
— Need Attention

A GFCI outlet may be missing in the kitchen. According to NEC 210.8(A), all kitchen receptacles serving countertop surfaces must have ground-fault circuit interrupter (GFCI) protection.

Without GFCI protection, there is an increased risk of electric shock, especially in areas near sinks or other water sources. This condition is a safety hazard and a code violation that should be corrected promptly.

Hire a licensed electrician to verify whether GFCI protection is present. If it's missing, the electrician should replace the existing receptacle with a GFCI outlet or install GFCI protection at the breaker.

Installing a GFCI outlet typically costs \$150–\$300, including materials and labor.

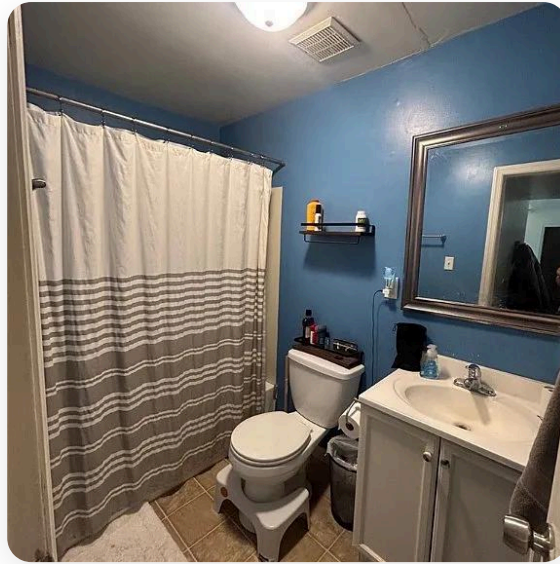
✓ Fine

No major issues observed

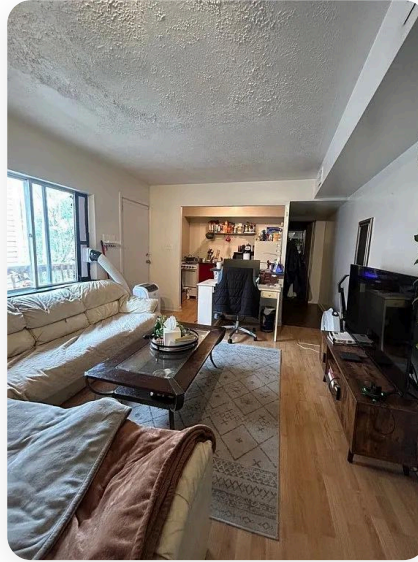
— Need Attention

Popcorn ceiling texture is present. Homes built before the 1980s often used textured ceiling materials that may contain asbestos.

If asbestos is present and the ceiling is disturbed during maintenance or remodeling, microscopic asbestos fibers can become airborne and inhaled, posing serious long-term health risks, including lung disease and cancer. Undisturbed material is generally not hazardous, but any sanding, scraping, or drilling can release fibers.

Do **not** disturb the ceiling. Contact a licensed asbestos abatement contractor to collect a sample and test it for asbestos content. If asbestos is confirmed, the contractor can provide safe removal or encapsulation options depending on the condition of the material.

Testing: **\$100–\$300** per sample.

Professional asbestos removal or encapsulation: \$2–\$7 per square foot, depending on area size and accessibility.

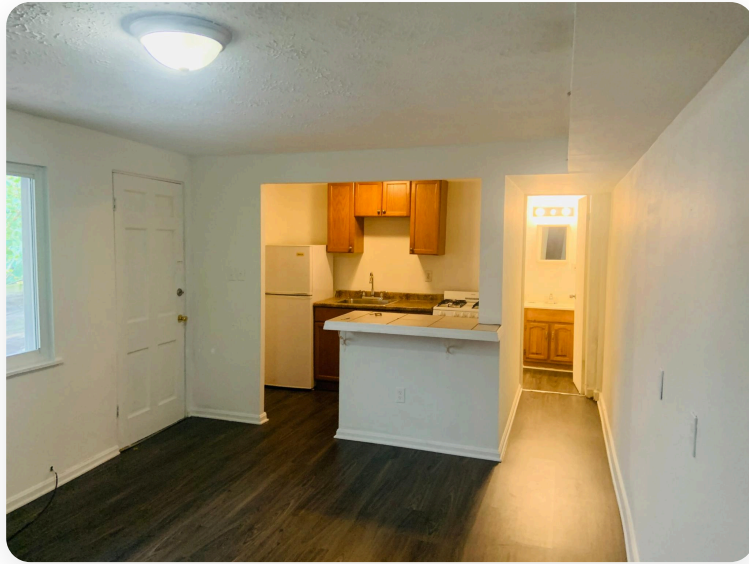
✓ **Fine**

No major issues detected from this photo

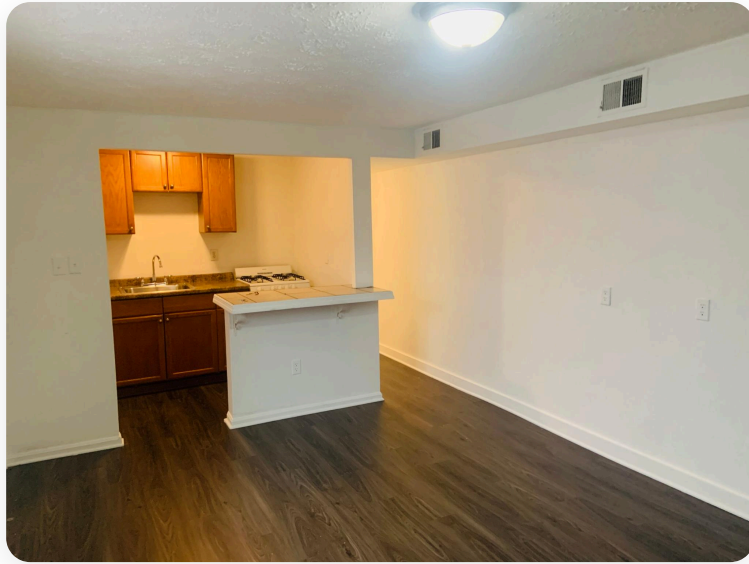
✓ **Fine**

No major issues detected from this photo

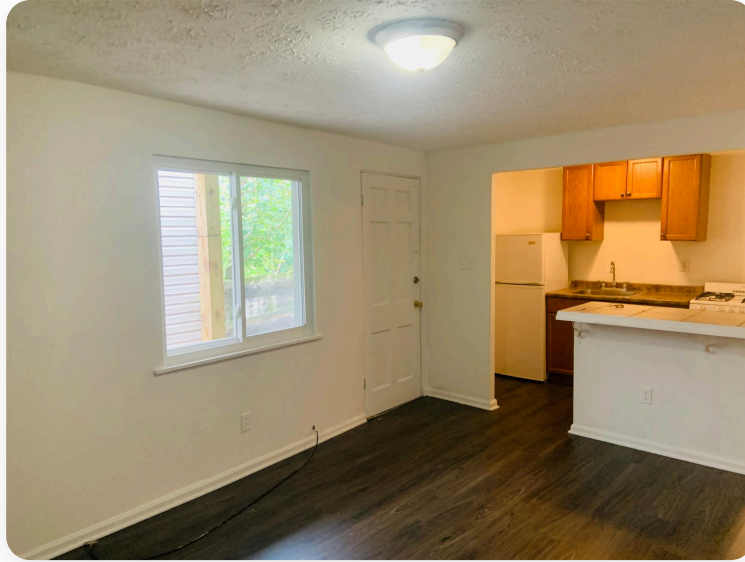
— Need Attention

Popcorn ceiling texture is present. Homes built before the 1980s often used textured ceiling materials that may contain asbestos.

If asbestos is present and the ceiling is disturbed during maintenance or remodeling, microscopic asbestos fibers can become airborne and inhaled, posing serious long-term health risks, including lung disease and cancer. Undisturbed material is generally not hazardous, but any sanding, scraping, or drilling can release fibers.

Do **not** disturb the ceiling. Contact a licensed asbestos abatement contractor to collect a sample and test it for asbestos content. If asbestos is confirmed, the contractor can provide safe removal or encapsulation options depending on the condition of the material.

Testing: \$100–\$300 per sample.

Professional asbestos removal or encapsulation: \$2–\$7 per square foot, depending on area size and accessibility.

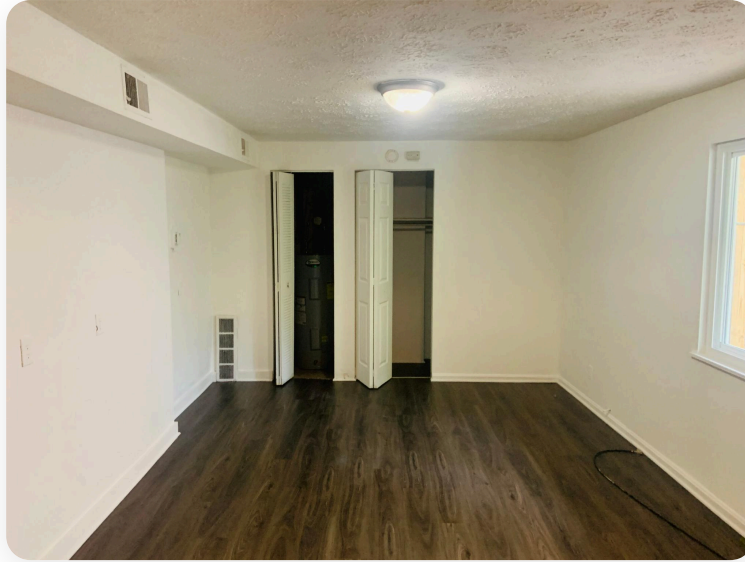
— Need Attention

The water heater is missing a required drain pan. According to IRC P2801.6, a drain pan must be installed under water heaters located in or above areas where leakage could cause damage (such as finished basements, attics, or interior rooms). The pan should be properly piped to a safe discharge location.

Without a drain pan, any leak or overflow from the water heater could cause significant water damage to floors, walls, or nearby finishes. Prolonged leakage can also lead to mold growth or structural deterioration.

Hire a licensed plumber to install an appropriately sized metal or plastic drain pan beneath the water heater, with a drain line routed to an approved discharge location. If the heater must be lifted to install the pan, the plumber can also inspect for signs of corrosion or leakage.

Installing a new drain pan and discharge piping typically costs \$250–\$600, depending on accessibility and the distance to a suitable drain location.

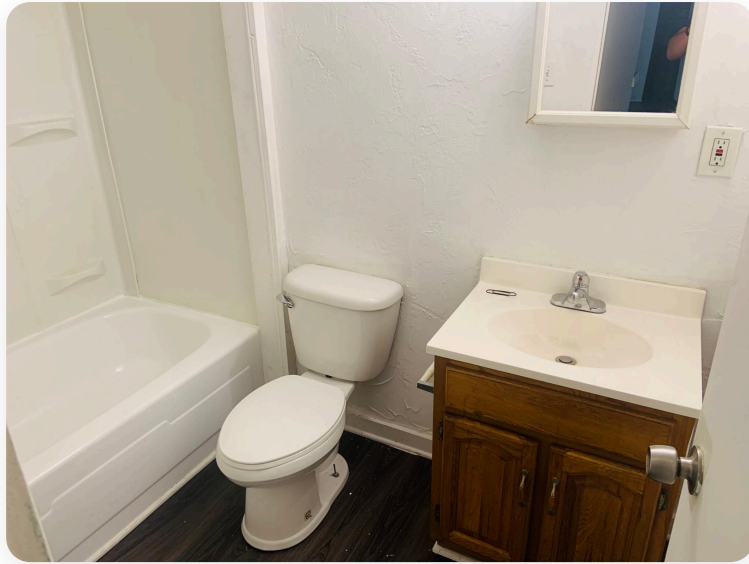
✓ **Fine**

No major issues were detected from the photo

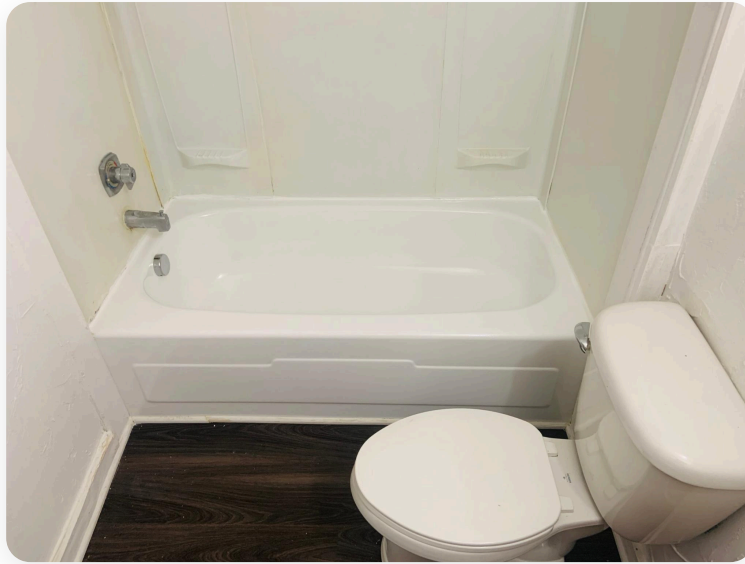
— Need Attention

Visible staining, consistent with mold or mildew growth, is present along the vertical seams of the fiberglass or acrylic shower surround panels. The sealant or caulk appears deteriorated and discolored at the junction between the tub deck and the wall panels. The wall paint adjacent to the tub surround also shows signs of poor finish quality and potential moisture exposure near the floor.

Compromised sealant allows water penetration behind the shower surround, potentially leading to concealed mold growth and structural damage to wall framing. Continued mildew growth poses a sanitation concern and may degrade the appearance and integrity of the shower unit. Water intrusion at the floor level risks damage to the subfloor and adjacent wall materials.

Thoroughly clean and treat all visible mold/mildew areas using appropriate fungicidal agents. Remove all deteriorated caulk and apply a fresh bead of mildew-resistant silicone sealant to all seams, ensuring a watertight barrier. Monitor the adjacent wall areas for signs of moisture intrusion or paint failure.

Total Cost Range: \$150–\$250 (Assumes no hidden damage requiring panel removal or drywall repair.)

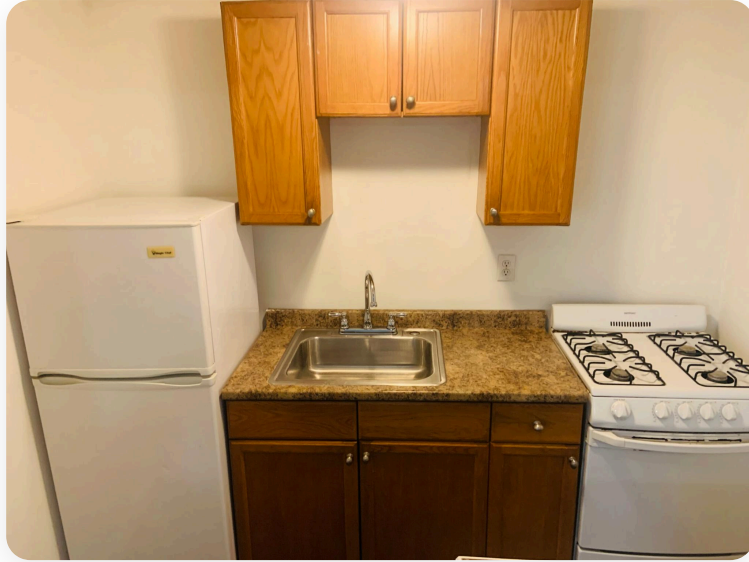
— Need Attention

GFCI protection is missing in the kitchen. According to NEC 210.8(A), all kitchen receptacles serving countertop surfaces are required to have Ground-Fault Circuit Interrupter (GFCI) protection.

Without GFCI protection, there is an increased risk of electric shock, especially in areas near sinks or other water sources. This poses a significant safety hazard and is a violation of current electrical code standards.

Hire a licensed electrician to install GFCI protection for all kitchen countertop outlets. This can be done either by replacing existing outlets with GFCI receptacles or by installing a GFCI breaker that protects the entire circuit.

Installing GFCI outlets typically costs \$150–\$300 per outlet, depending on accessibility and existing wiring conditions.
